Report on Preliminary Geotechnical Assessment

Great Keppel Island Resort Revitalisation Project

Prepared for GKI Resort Pty Ltd

Project 74586.00 August 2011

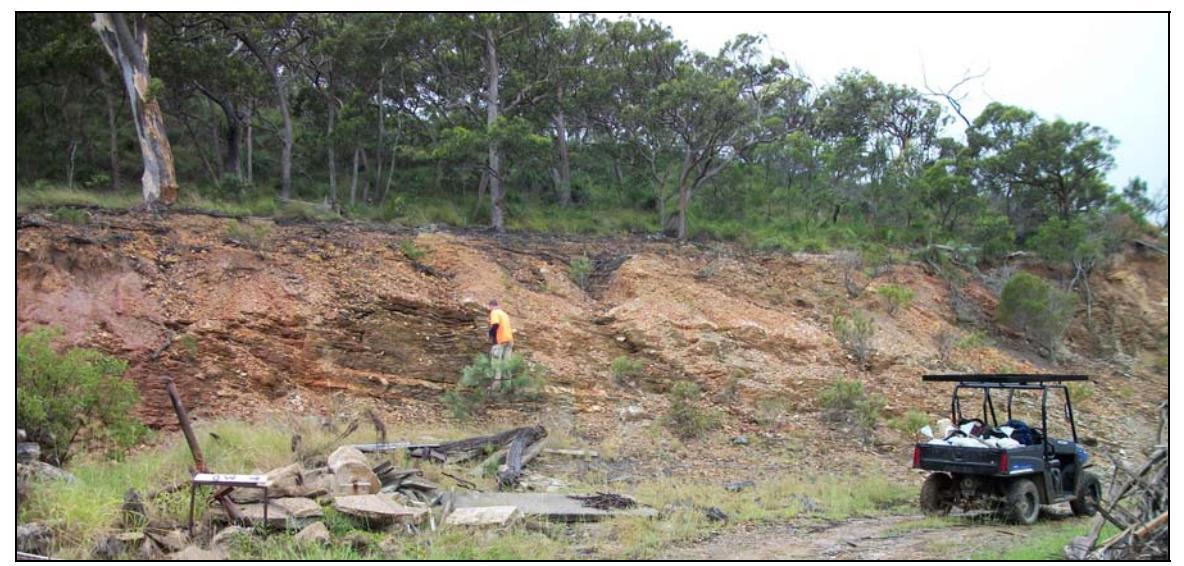
Figure 1: General Photograph of Quarry Site

The exposed face within the quarry was inspected and photographs of the quarry site and general rock exposure are presented below as Figure 1 and Figure 2

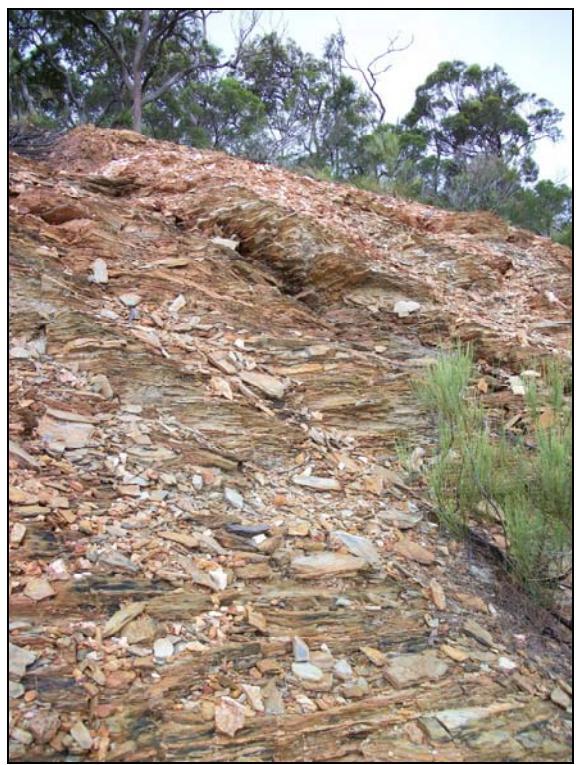
Figure 2: Photograph of Rock Exposure at Quarry Site

The rock was observed to comprise low strength (and stronger) quartzose sandstone with distinct quartz veins. The bedding was thinly laminated and generally aligned on a bearing of 320 degrees, and dipping into the face at approximately 8 to 10 degrees with a dip direction of 50 degrees.

Surface geology encountered, as described in Section 6 above, generally comprise sand to depths of between 1 m and 1.2 m at the locations tested. Rock outcrops comprising low strength (and stronger) quartzose sandstone were observed in several locations in close proximity to the locations tested.

A preliminary assessment of the rock outcrop indicates that large hydraulic excavators fitted with hydraulic rock hammers and/or large dozers with medium to hard ripping and low productivity may be required for excavation of the observed low strength (or stronger) rock. The ease of excavation in rock is dependent upon several factors including rock strength, defect spacing, defect orientation, bedding thickness, machine size and operator skill.

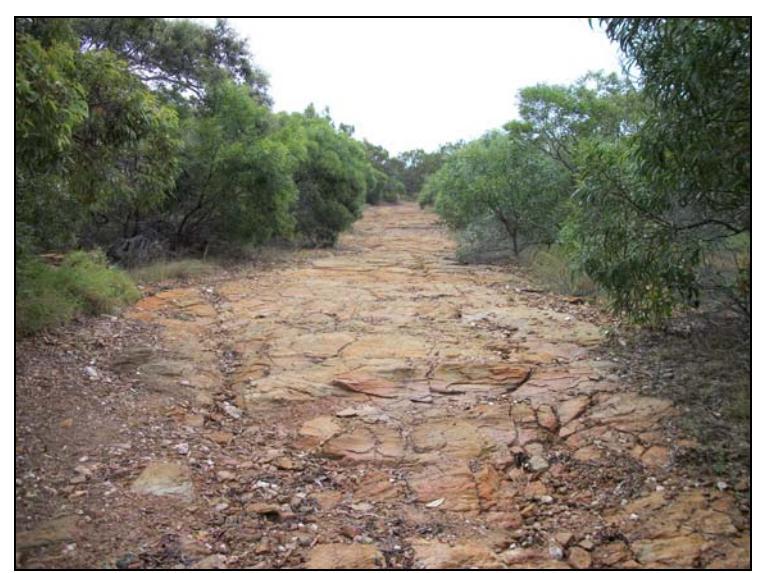
Figure 3: Rock Exposure at Surface of Road on Eastern side of Lookout

Rock outcrops were also observed along the access road to the lookout and generally formed the surface of the access road down to the eastern side of the lookout ridgeline (Figure 3) and along the access track from the Quarry to Long Beach (Figure 4) between Bores HA1 and HA2.

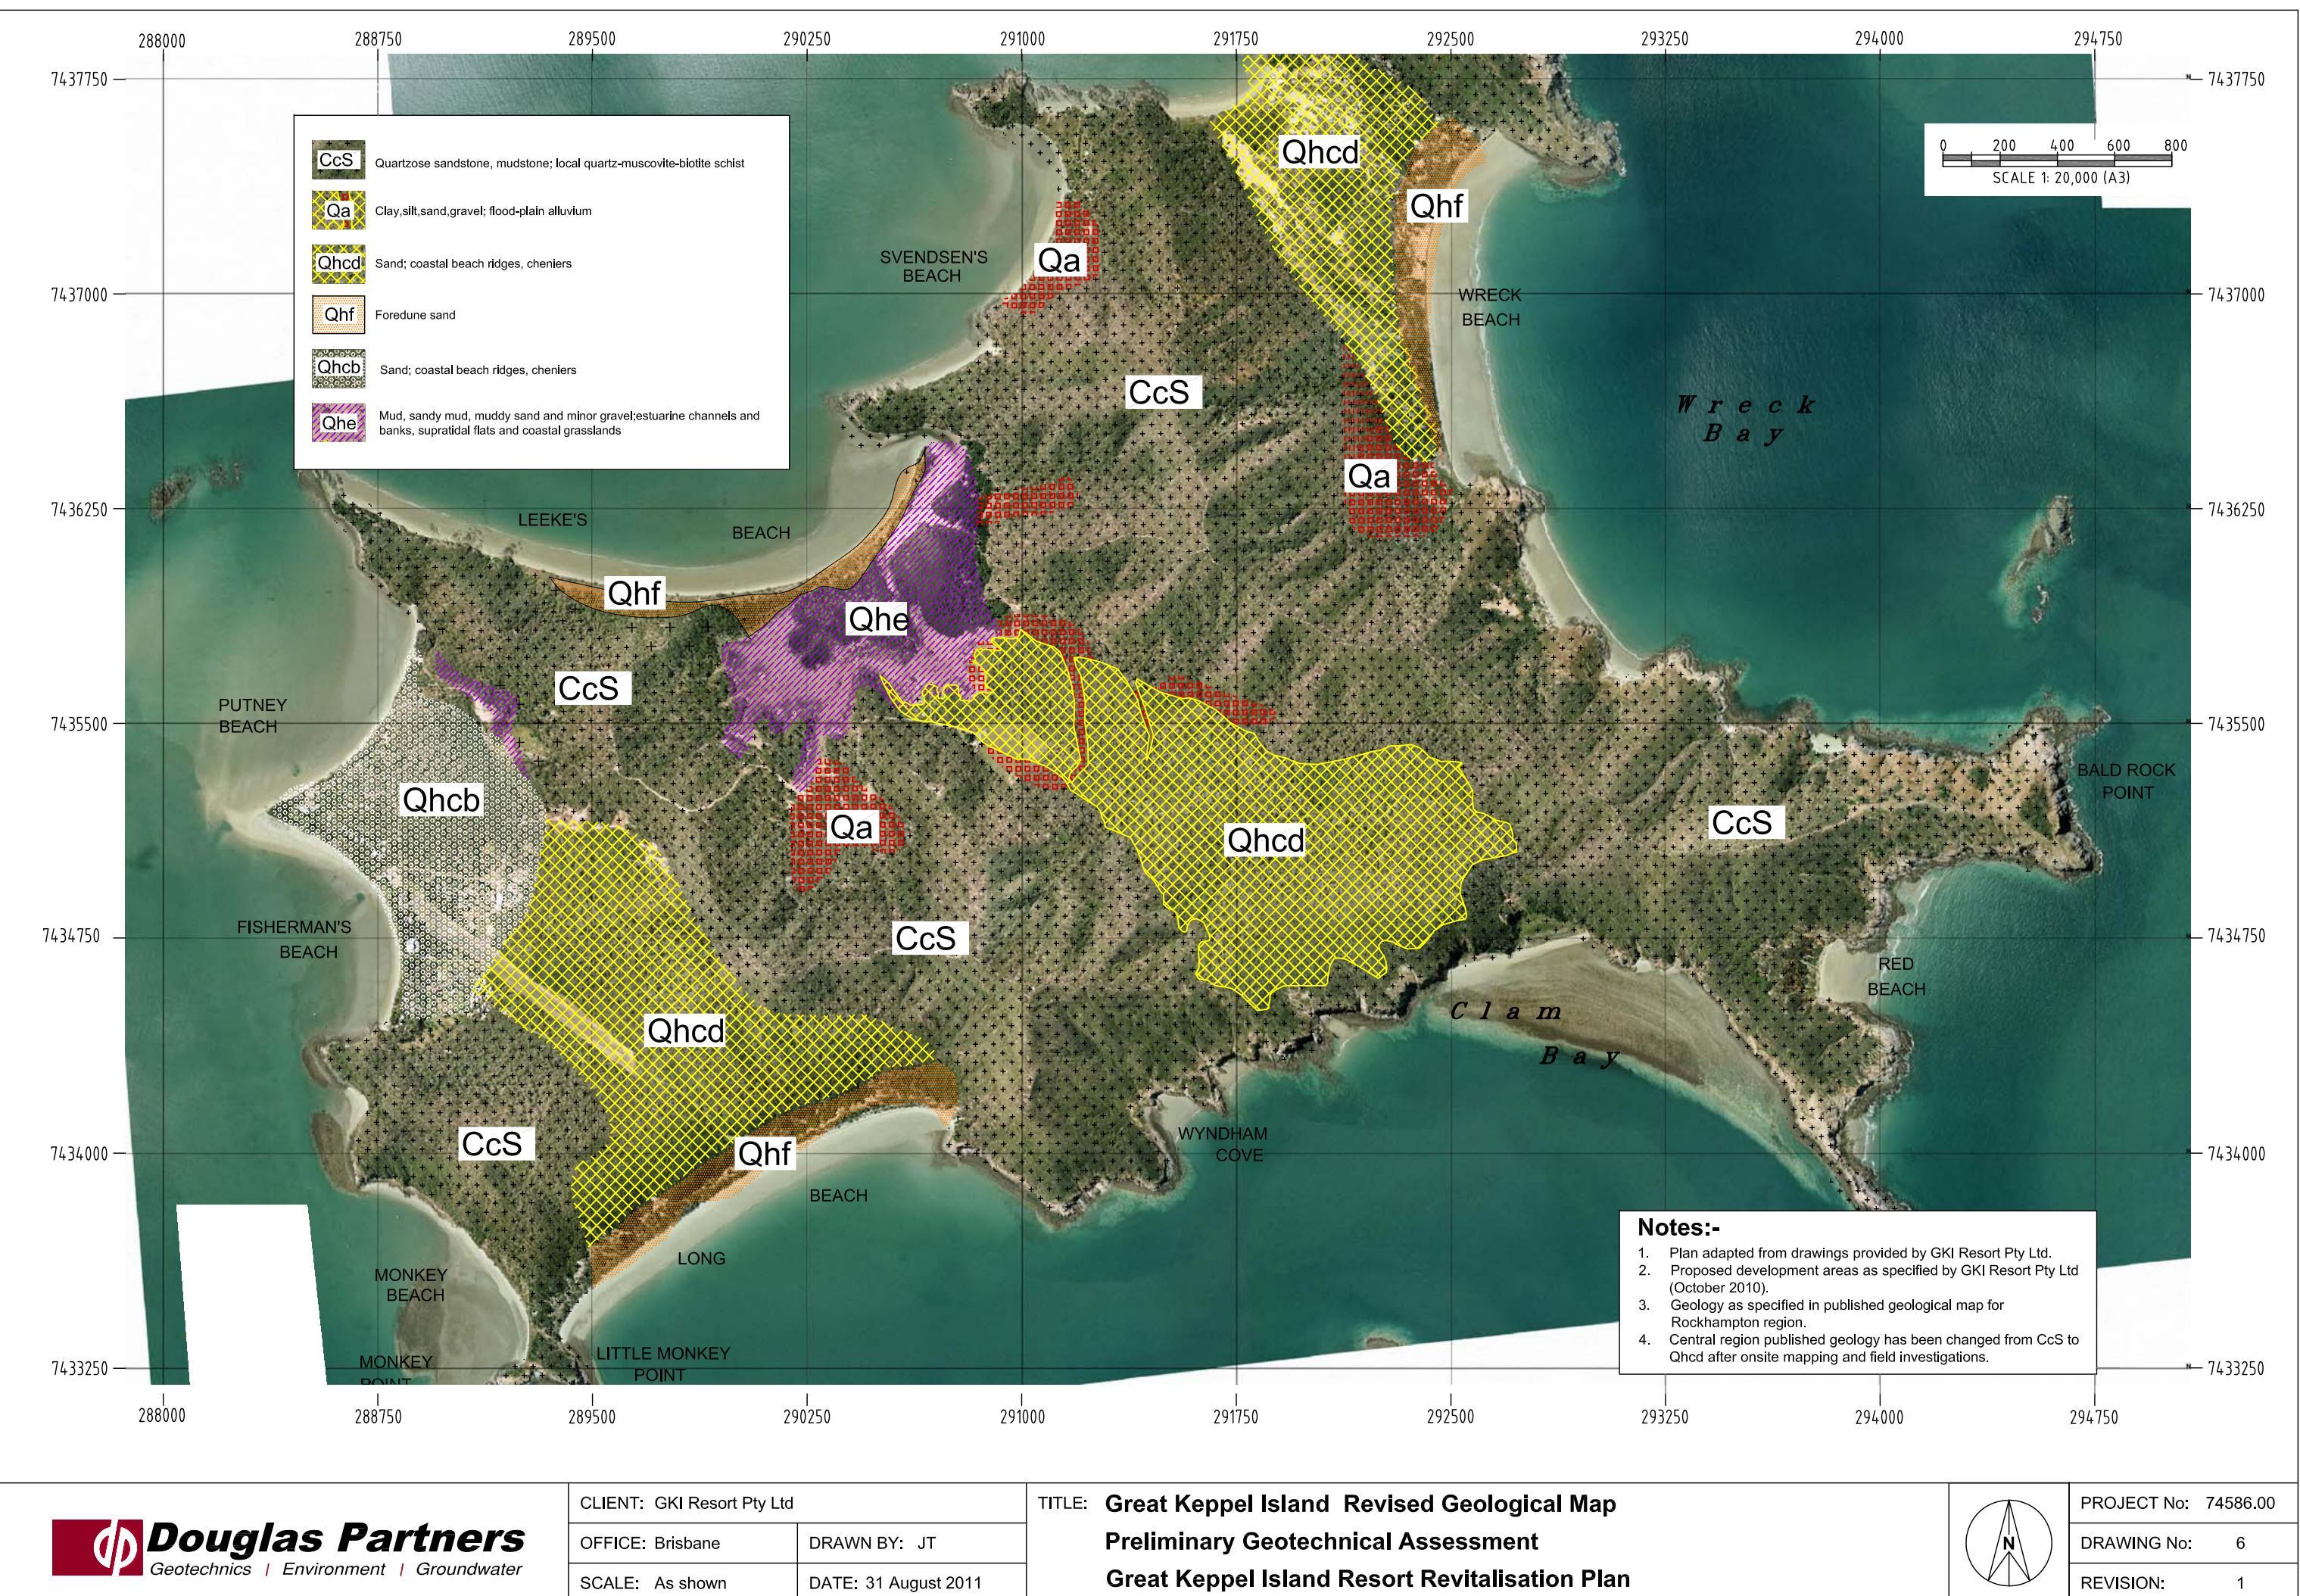
Drawing 6 – Great Keppel Island Revised Geological Plan

The lateral extent of the sand deposit encountered in the central area of the island was found to be more extensive than that shown on the published geology (Dept of Natural Resources, Mines & Water, 2006). Sands encountered are considered to be a mixture of dune sands and colluvium. The approximate extent of the sand deposit is shown on Drawing 6.

In the central area of the island, proposed for golf course development, a large deposit of sand was encountered and was found to be more extensive than the published geology (Dept of Natural Resources, Mines & Water, 2006). Sands encountered in the central area of the island were considered to be a mixture of dune sands and colluvium. An interpretation of the surface geology based on the results of this assessment is shown on Drawing 6.
